**CWA COMPLIANCE EVALUATION INSPECTION REPORT
U.S. ENVIRONMENTAL PROTECTION AGENCY, REGION 5**

Purpose: Compliance Evaluation Inspection

Facility: Benton Dairy, LLC

Date of Inspection: April 28 and 29, 2021

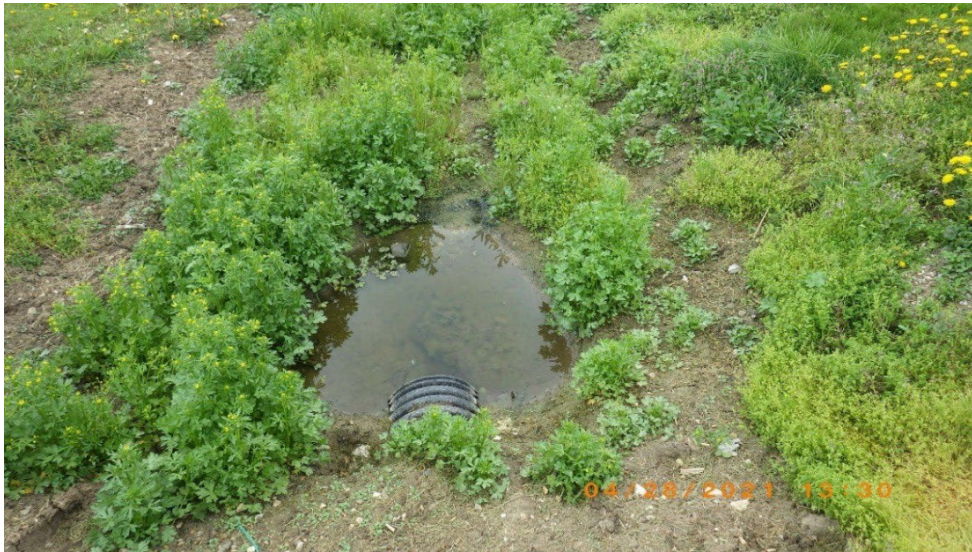
Photo Number: RIMG0183

Description: The drainage outlet from between Barn 4 and Barn 3 into the East Drainage Channel east of the East Access Road.

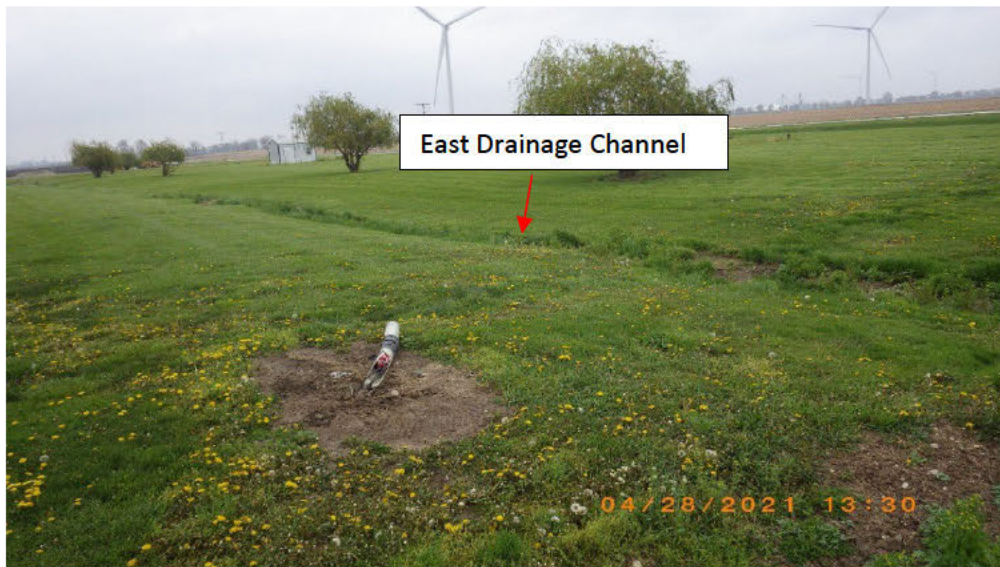
Photo Number: RIMG0184

Description: The East Drainage Channel on the east side of the facility east of the east access road.

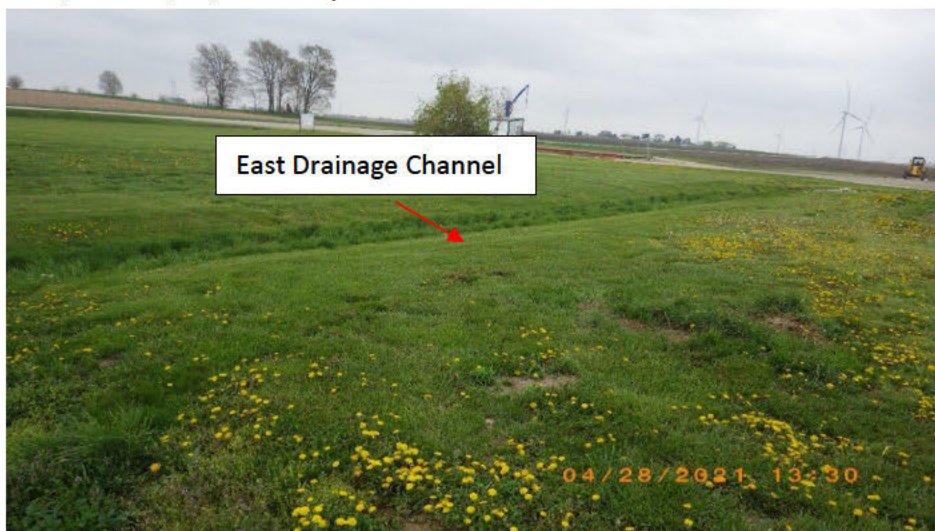
Photo Number: RIMG0185

Description: The East Drainage Channel that collects flow from between the barns.

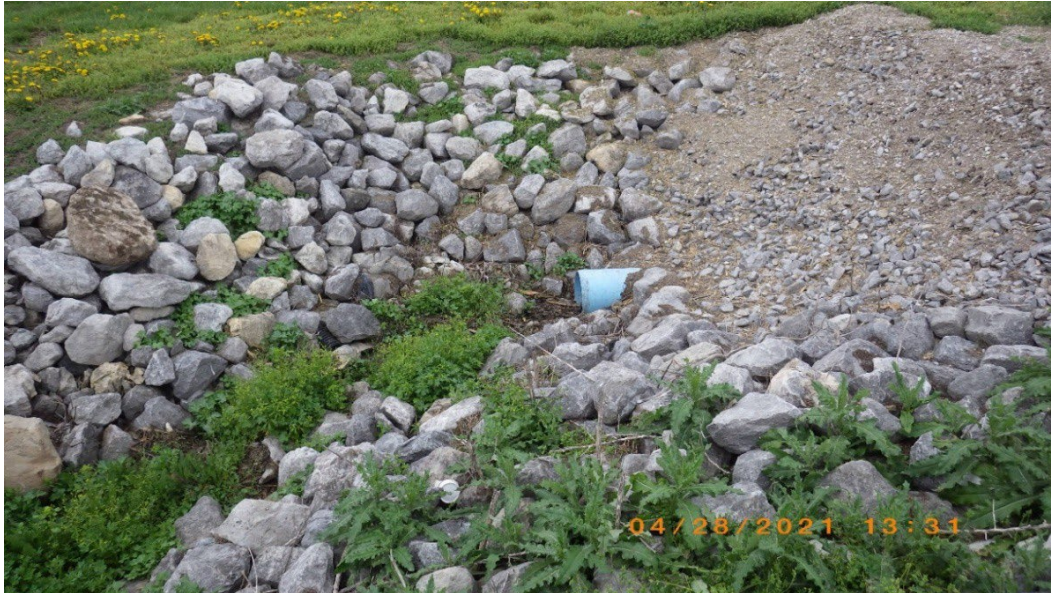
Photo Number: RIMG0186

Description: The drainage outlet conveys the stormwater and process wastewater from what is pushed out of the barns and conveys it under the East Access Road to the East Drainage Channel into the Stormwater Pond.
